Cochlear implant electrode displacement: a case series

Reviewing cases of extracochlear electrode array placement in children with cochlear implantation (CI)

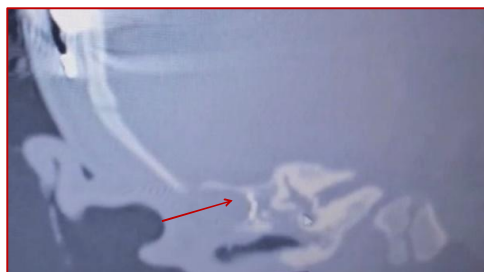
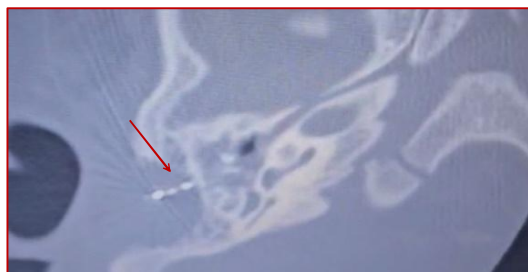
In the case of the 3-year-old child who underwent cochlear implantation in the right ear using a SYNCHRONY STANDARD electrode array from MED-EL, several key points stand out: surgical procedure: the cochlear implantation surgery was performed in a standard manner without any intraoperative peculiarities. This suggests that the surgical technique itself was likely appropriate and adhered to standard protocols. Electrode Characteristics: The electrode array used had a length of 31.5 mm, which is within the typical range for pediatric cochlear implantation. This indicates that the chosen electrode was suitable for the child's anatomy and age. Intraoperative Telemetry: The intraoperative telemetry reading of 0.42 Ohm indicates that the electrode was appropriately inserted and had good contact with the cochlear structures. A low impedance reading is typically indicative of good electrode placement. Autoart Registration: The positive autoart registration on all channels further confirms the adequacy of electrode placement and suggests that the electrode was functioning correctly and stimulating the auditory nerve effectively. Postoperative Imaging: The X-ray performed on the second day after surgery revealed that the electrode array was located in the projection of the mastoid cavity, indicating extracochlear placement. This represents a deviation from the intended intracochlear positioning within the cochlea.

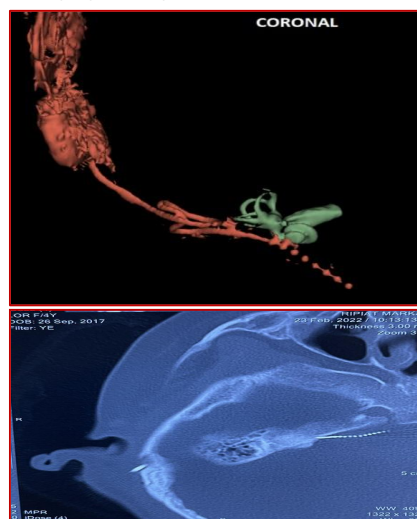
In the second case: A 4-year-old child underwent cochlear implantation in the right ear using a SYNCHRONY STANDARD electrode array from MED-EL, with a length of 31.5 mm. The surgery proceeded without any intraoperative features or complications. Intraoperative telemetry measured a reading of 1.02 Ohm. Autoart registration was recorded on channels 10-11-12. Postoperative radiography of the temporal bones revealed that the electrode array was located in the projection of the auditory tube, with its end positioned at the level of the nasopharynx. This description provides a clear overview of the second case, highlighting the relevant surgical details and postoperative imaging findings.
